# Situation Photo Log

Friday, December 7, 2012

Kalamazoo River / Enbridge Spill

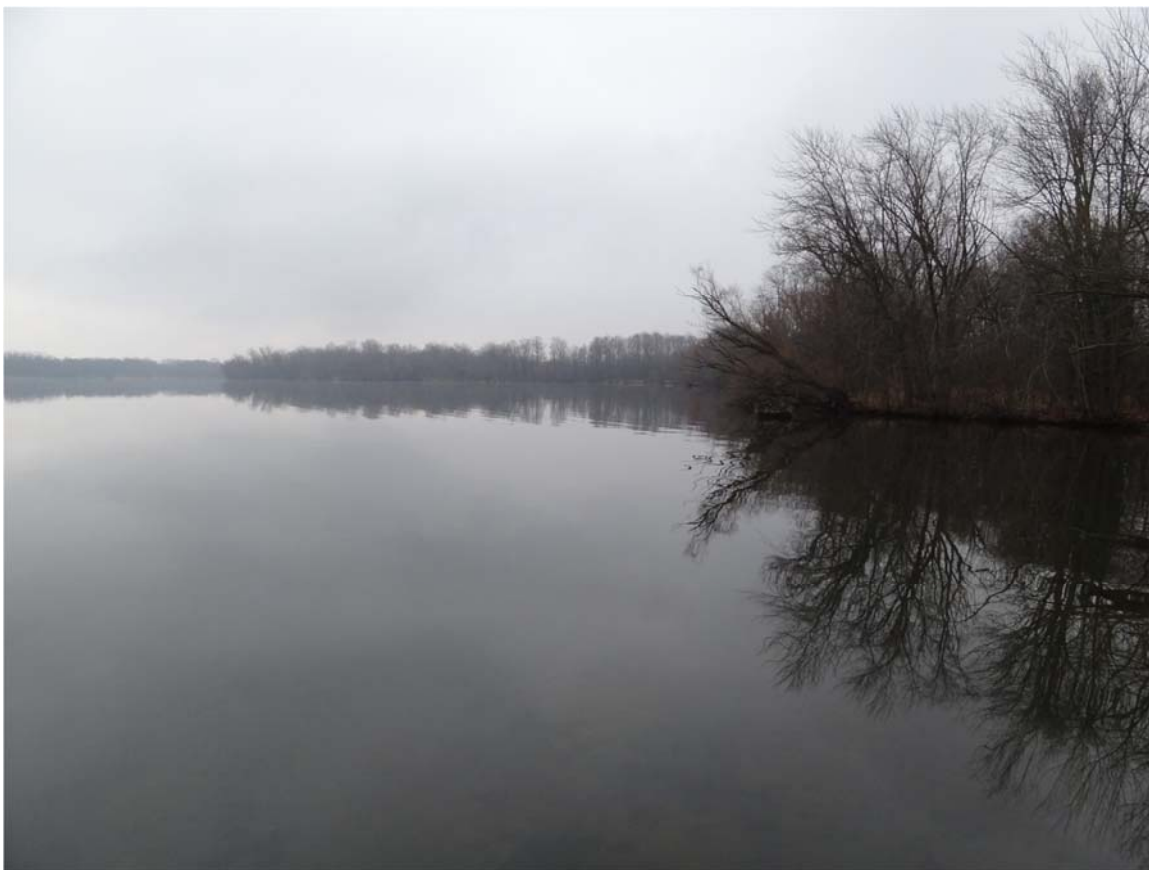
**27. Morrow Lake South Cove area where sheen and tar globs were observed.  
Sheen sweep requested.**

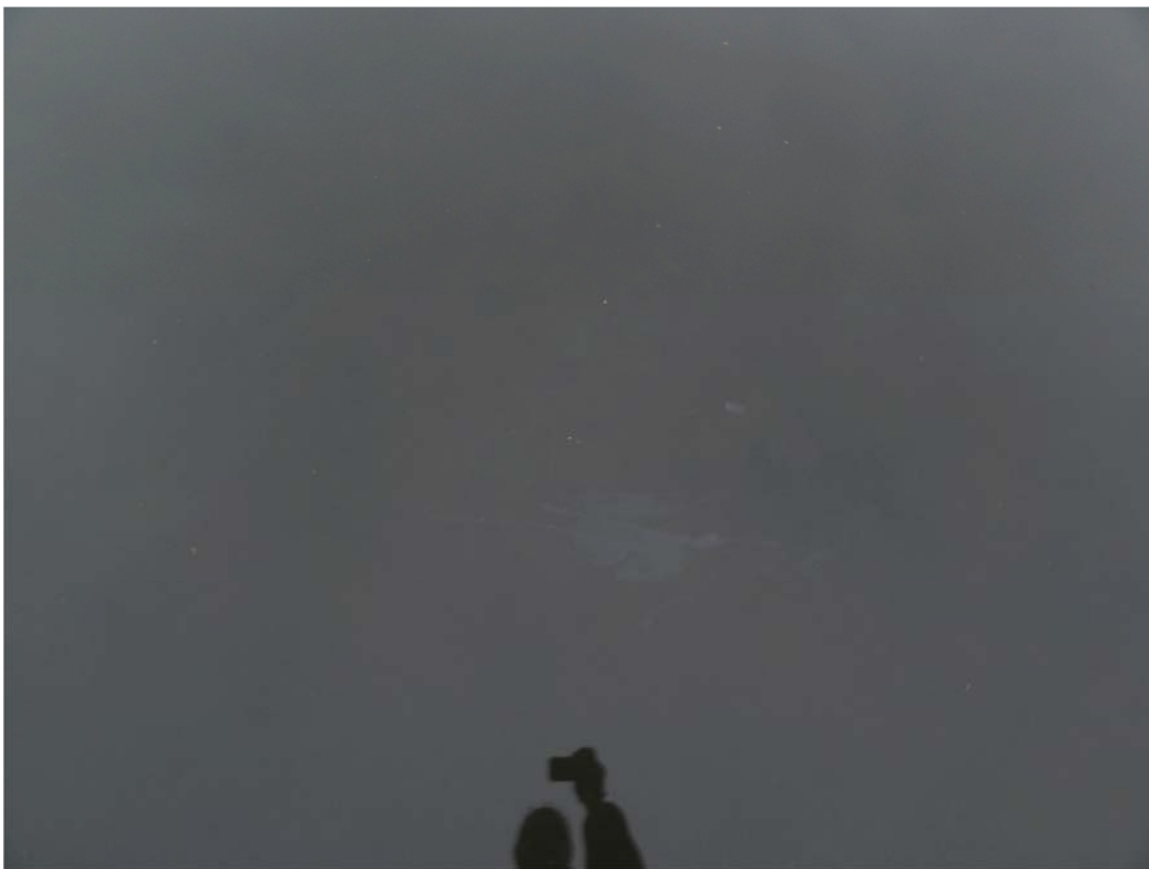
**28. Morrow Lake South Cove sheen and tar globs observed. Sheen sweep  
requested.**

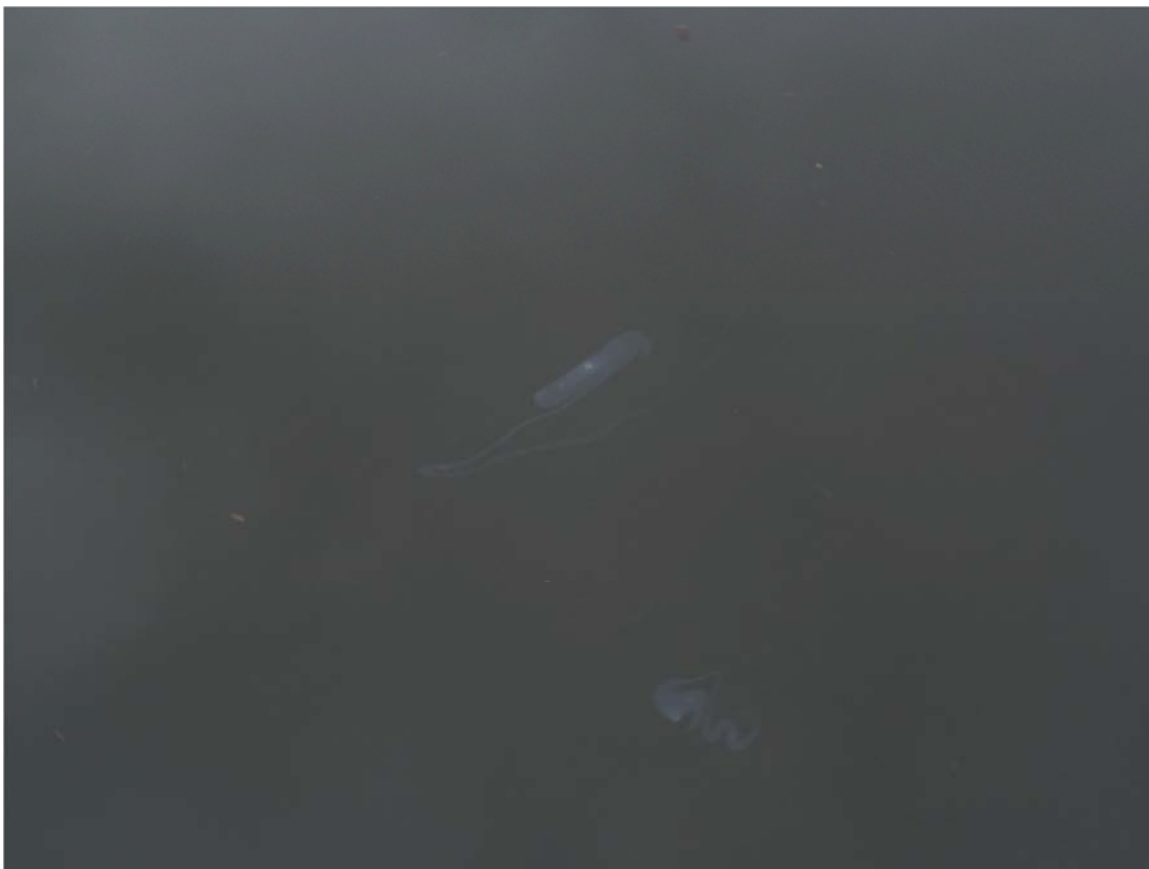
**30. MP37.75 Morrow Lake/Delta Neck observed sheen and tar globs.**

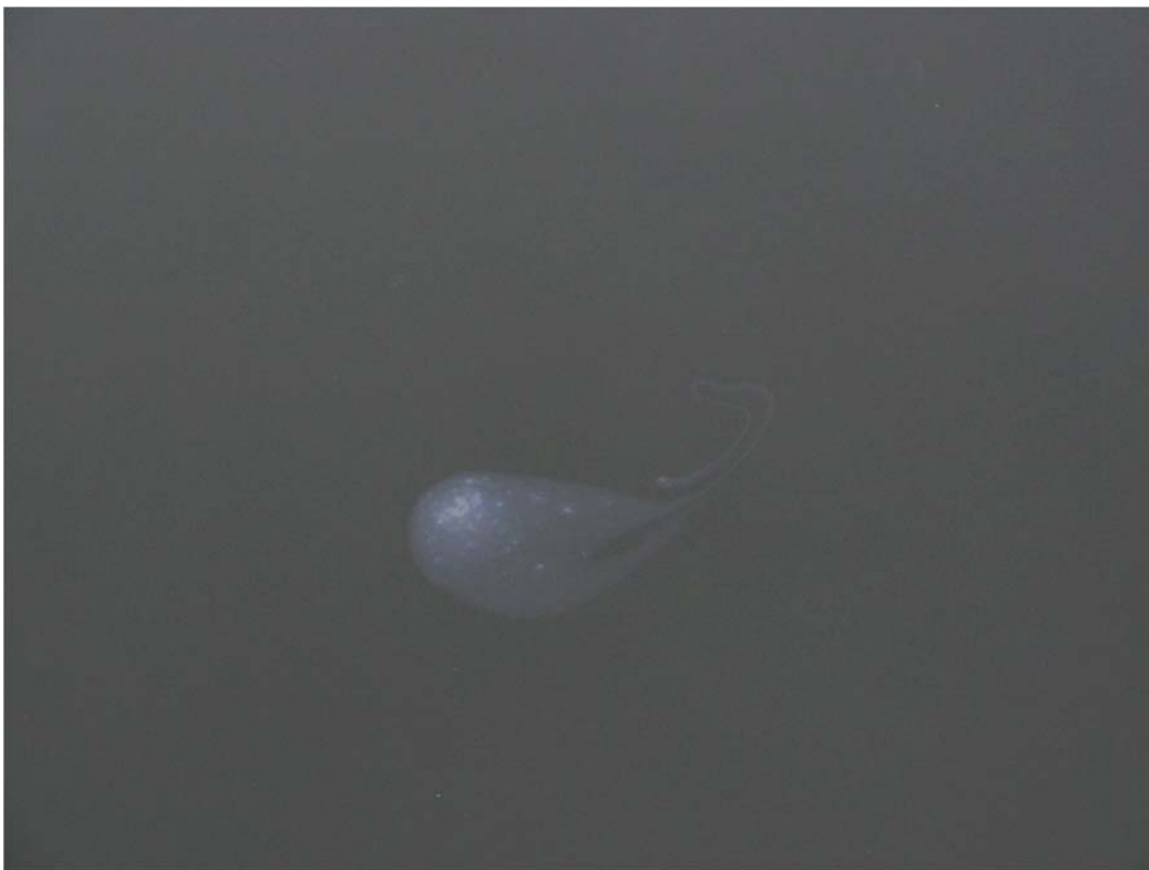
31. MP37.75 Morrow Lake/Delta Neck observed sheen and tar globs.
